TECLA Housing Post-Earthquake Damage Assessment Habitat for Humanity Haiti September 2021

Examining Habitat for Humanity Haiti's TECLA houses after the August 2021 earthquake

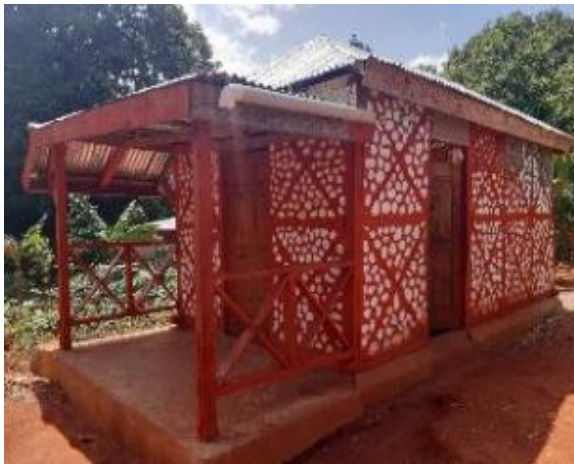
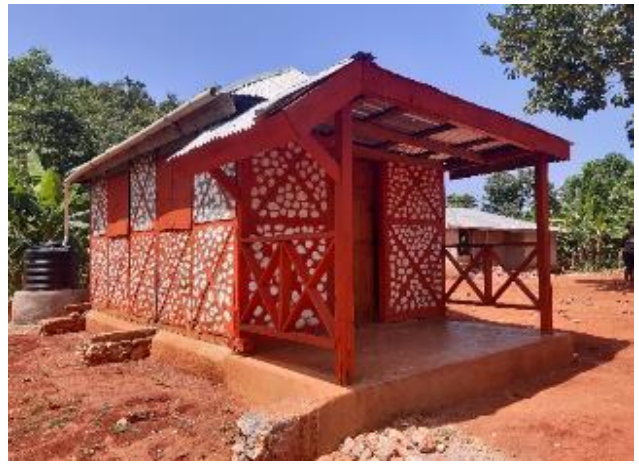
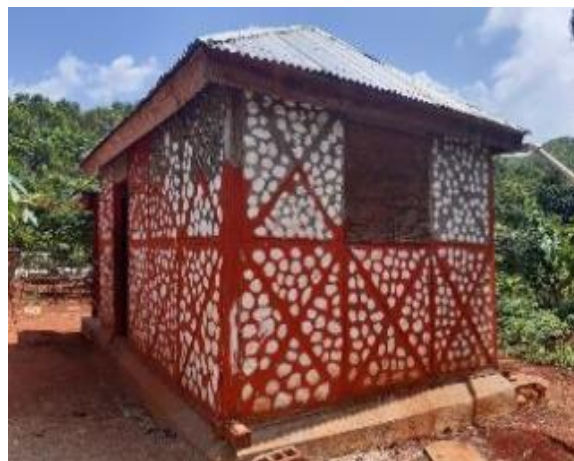
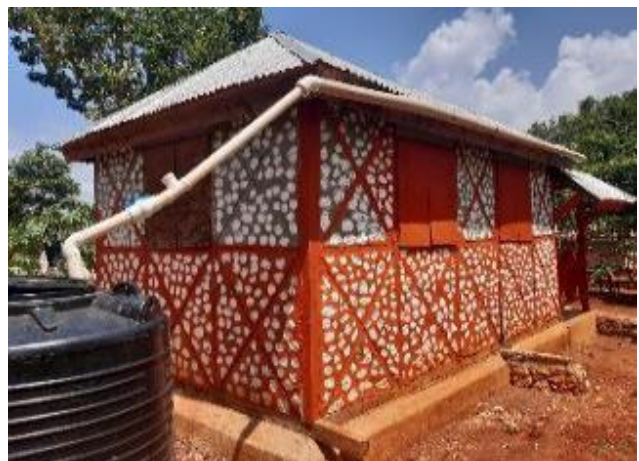
House of Etienne Tarline, built in Baie Trinette, Pestel (Grand'Anse)

The "no damage " category includes the houses that stood firm and have not suffered any structural damage, with no cracks or broken components.

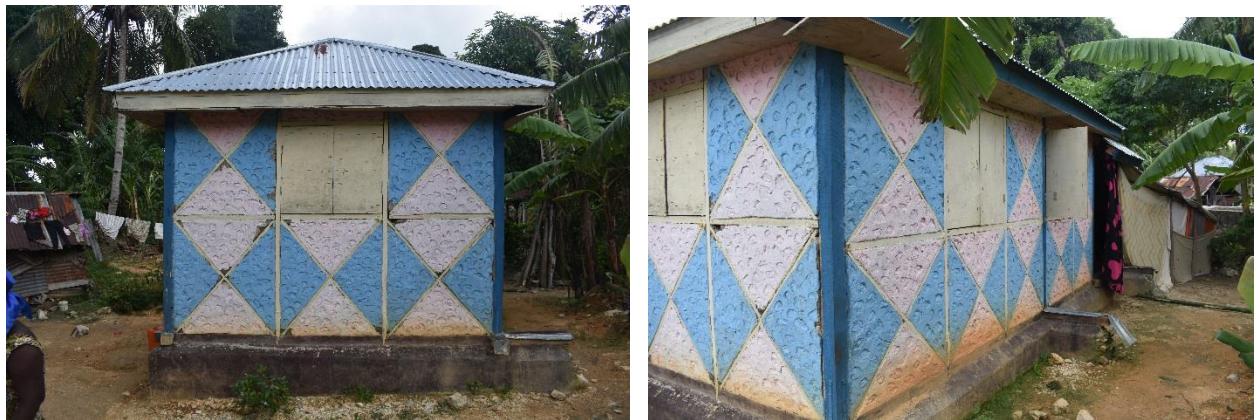
2. **Minor impact or damage:** The “minor damage” category includes the houses that have instances of:
- a. Stone masonry collapsed in one (1) to three (3) triangles from the braced panels
 - b. Showing minor cracks
 - c. Having the stone masonry unsealed on the bracing.

Such damages can be repaired within one day by one of the local masons previously trained by HFHH during the Hurricane Matthew response. Families with basic construction skills could also ensure such repair.

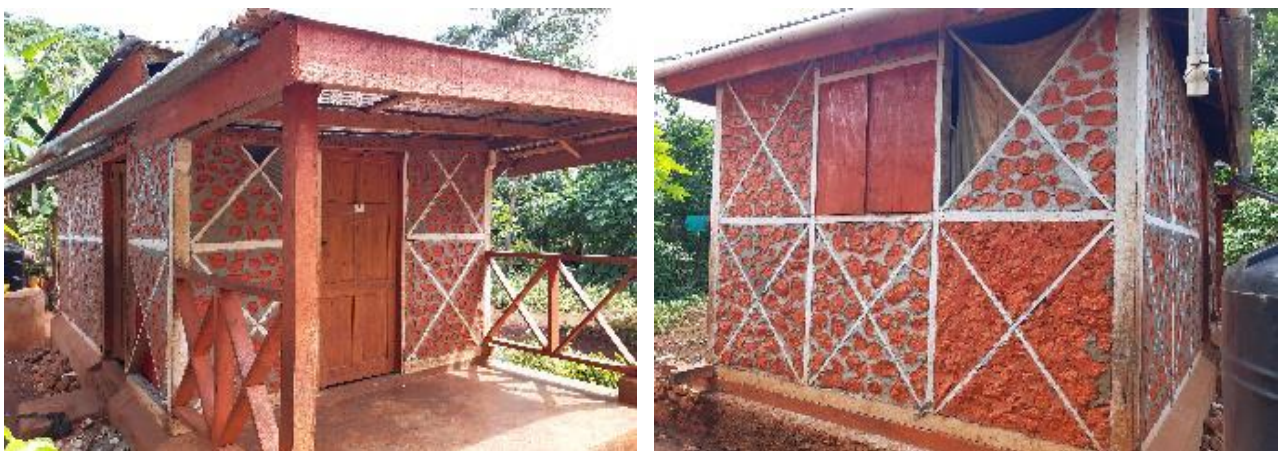
House of Christiane Lucien in Lassale, Pestel Grande' Anse

3. **Moderate impact or damage:** The “moderate damage” category includes:
- a. Houses that have one (1) to three (3) braced panels broken
 - b. The stone masonry collapsed in some of the braced triangles

Such repair requires skilled masons; most likely the ones trained during the previous Hurricane Matthew disaster response project, using the TECLA techniques and most of the collapsed masonry elements as most of the filling materials are recyclable.

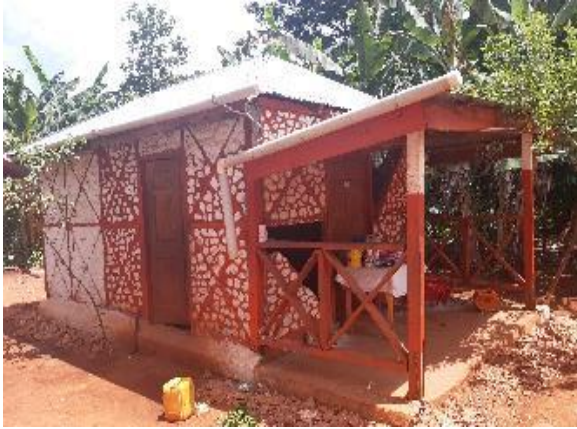
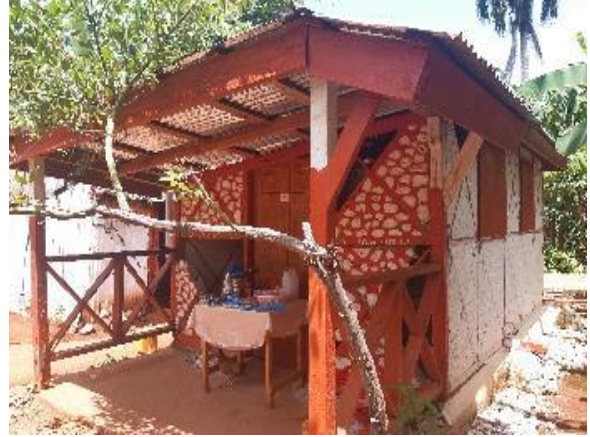
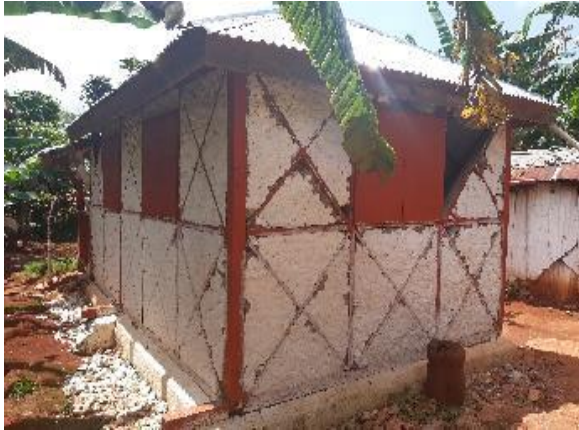
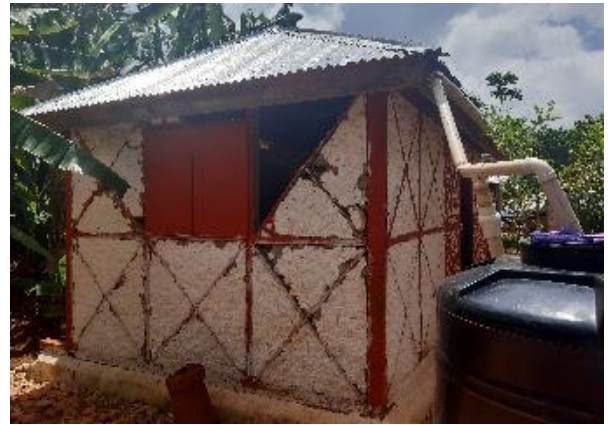
House of Maude Fremont in Cagousse, Pestel, Grande 'Anse

4. **Severe impact or damage:** The “severe damage” category includes:
- a. Houses that suffered moderate damages AND one or more main posts, as well as intermediary post were broken by the effects of seismic lateral forces, causing the whole wall to bend or collapse.

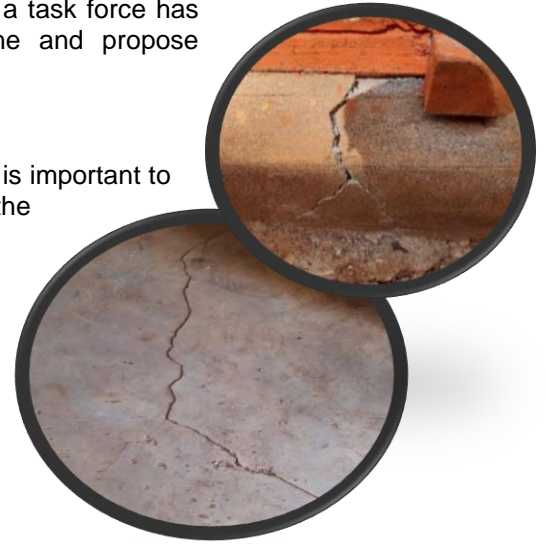
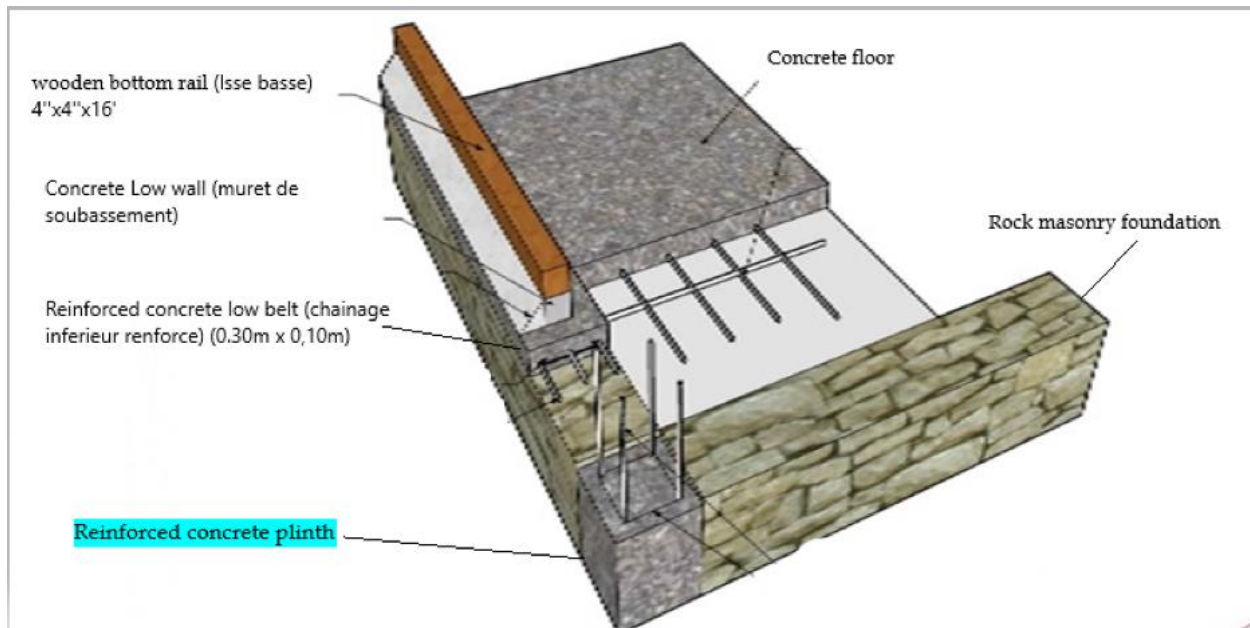
Proposed reinforcement of the foundation and floor

- **Observations**
 - Major cracks and detachment at the corners in the foundation masonry (low wall).
 - Major cracks in the concrete floor
- **Causes**
 - Ground pounding motion during the earthquake
 - seismic waves passing underground in the surrounding
- **Suggested improvements**
 - Addition of a reinforced concrete belt (lower chainage) 0,30m x 0,10m on the top of the concrete masonry foundation
 - Addition of 0.30m x 0.30m reinforced concrete pedestals in the corners of the masonry
 - Reduction of the distance of the keys in the masonry to a maximum of 0.80m instead of 1.20m

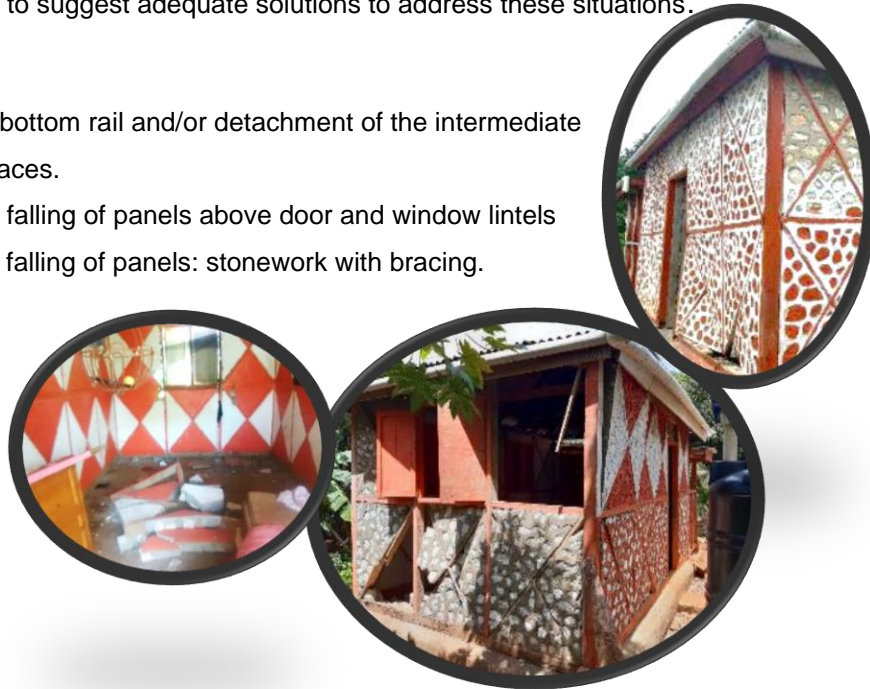
- Breakage of the bottom rail and/or detachment of the intermediate posts in some places.
- Detachment and falling of panels above door and window lintels
- Detachment and falling of panels: stonework with bracing.

- Loss of resilience of wood due to rotting caused by moisture well before the earthquake
- Insufficient anchoring (number of nails) of stone masonry on the lintel elements of doors and windows
- Insufficient anchoring (number of nails) of the stone masonry on the laths constituting the cross bracing (St. Andrew's Cross)

- Better preparation or treatment of the wood in general, but especially of the bottom rail and posts: use of zinc chromate and paint or other treatment method
- Covering the bottom rail with plastic on the upper and outer sides, plus iron mesh to facilitate plastering.
- Increasing the height of the low wall and spreading a drainage layer on the slope to facilitate rainwater runoff on the ground outside the foot of the foundation
- Increasing the anchorage by adding additional nails in the crossbars
- Adding welded mesh or a 5cm x 5cm grid binding net on the inside of the panels to limit human damage

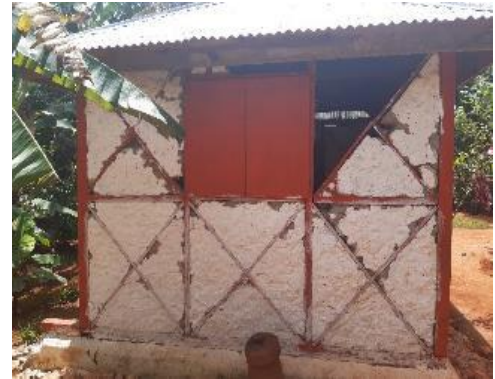
- The rear facade of the houses is usually more affected than the others

- Irregularity in the distribution of the wall panels across the width

- Addition of two (2) new interior panels in the width direction, for a better redistribution of the forces
