# Housing Stock and Management Assessment of Multi-Apartment Buildings in the Western Region of Ukraine

Author: Center of Local Government Studies

Publication date: July 2025

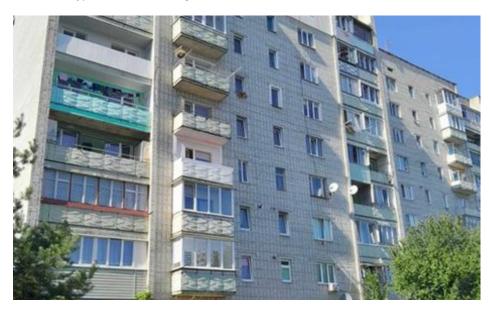
Picture 1. Typical Czech building 1

In addition, 24 MABs were identified in line with a specific housing series built during the Khruschshev era of 1953-1964 — hence the unofficial title Khrushchevka — while 19 MABs fall into another unofficial typology — the Czech buildings — and 9 MABs have a combined red and silicate brick wall construction, which the research team allocated to a separate category.

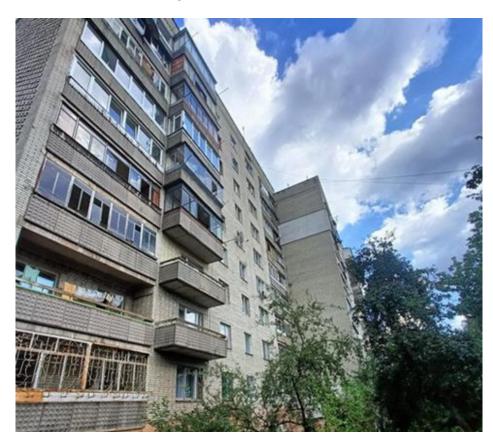
Picture 6. Brick house building.

construction types assessed in the sample MABs varies only slightly. Red brick performs about 5% better than concrete panel construction and slightly better than silicate brick construction. The Czech series MABs have an even higher heat loss due to the inclusion of uninsulated balconies and erkers façade elements.

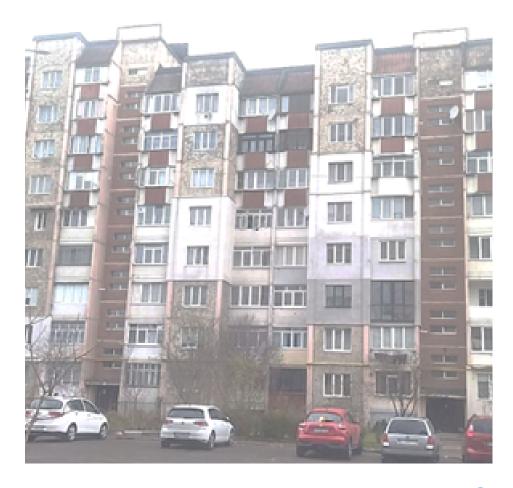
It is important to note that patchwork insulation does not have an overall positive effect on the thermal performance of a MAB. On the contrary, partial insulation can have a negative impact on living conditions and comfort: it causes external wall temperature differences and shifts the dew point inside the wall, causing moisture accumulation and temperature decrease to neighboring apartments.

**Picture 4.** Partially insulated facade of a MAB in the city of Kalush.

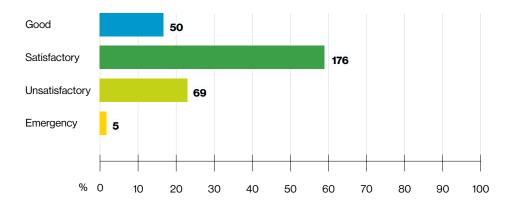
The condition of most facades (58,7% – 176 MABs) was categorized as satisfactory.

The number of facades in unsatisfactory condition was determined for 69 MABs (23%). This is the most worrying finding as each of these urgently requires facade repair in order to avoid further deterioration and reach 'emergency' condition.

5 MABs (1.7%) were found to already have reached the 'emergency' phase, while 50 MABs (16.7%) have facades in good condition.

Figure 16. Condition of the facades of the assessed buildings.

The 74 MABs with unsatisfactory and emergency condition facades require urgent intervention to prevent deeper deterioration of the wall.

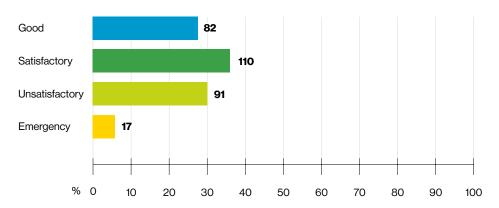
Approximately one third of the inspected buildings (82 MABs) have roof coatings in good condition. One third showed a satisfactory condition (110 MABs) and the remaining buildings fall within the unsatisfactory or emergency categories. The small percentage (5,7%) showing emergency roof conditions will require immediate repair.

Figure 16. Roof condition of the assessed buildings.

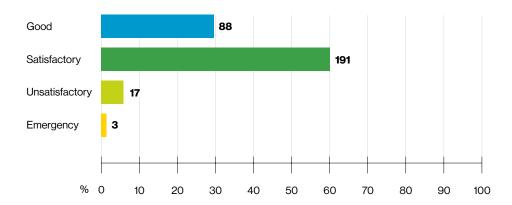
Figure 19. Foundation condition of the assessed buildings.

As can be seen in Figure 19, a majority (63,7%) of the buildings' foundations was in satisfactory condition. In addition 29,3 % of inspected buildings (88 MABs) were in good condition. Overall, this is an encouraging result. Over 90% of the assessed MABs did not exhibit any serious technical problems with their foundations, indicating quality construction and engineering expertise during their construction.

A small percentage (10 %) of the assessed MABs require urgent repairs to their structural foundations. These MABs are located in Mukachevo, Kalush, Lviv, Khust, and Kolomyya.

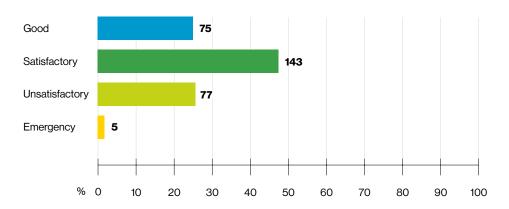
The state of water supply systems in 47,7% of the surveyed buildings is satisfactory (143 MABs) and in 25% it is in good condition (75 MABs). A quarter of the MABs had unsatisfactory condition of water supply systems (77 MABs) and in 5 MABs, an emergency state was noted and urgent repairs required.

Figure 22. Condition of water supply systems in the assessed buildings.

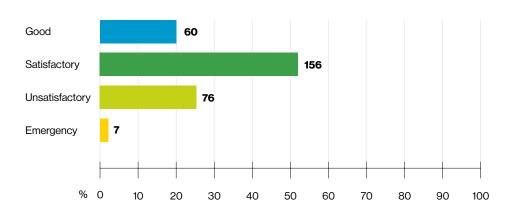
Figure 23. Condition of sewerage systems in the assessed buildings.

As stated above, an emergency state of sewerage systems correlates with an emergency state of water systems. These buildings require urgent repair to safeguard the health and well-being of the inhabitants.

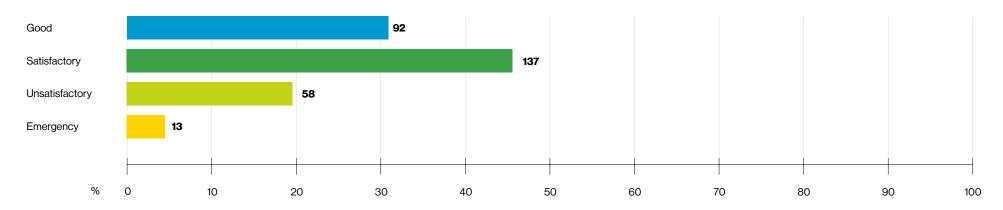
The condition of the electrical systems in 45,7% of the surveyed MAB was found to be satisfactory (137 MABs) and 30,7% were declared in good condition (92 MABs). This shows an overall adequate outcome of 76.4% MABs with safe electrical installations. Unsatisfactory and emergency conditions were found for 19,3% and 4,3% respectively.

Figure 24. Condition of the electrical systems of the assessed buildings.
