TECLA Housing Post-Earthquake Damage Assessment Habitat for Humanity Haiti September 2021

Examining Habitat for Humanity Haiti's TECLA houses after the August 2021 earthquake

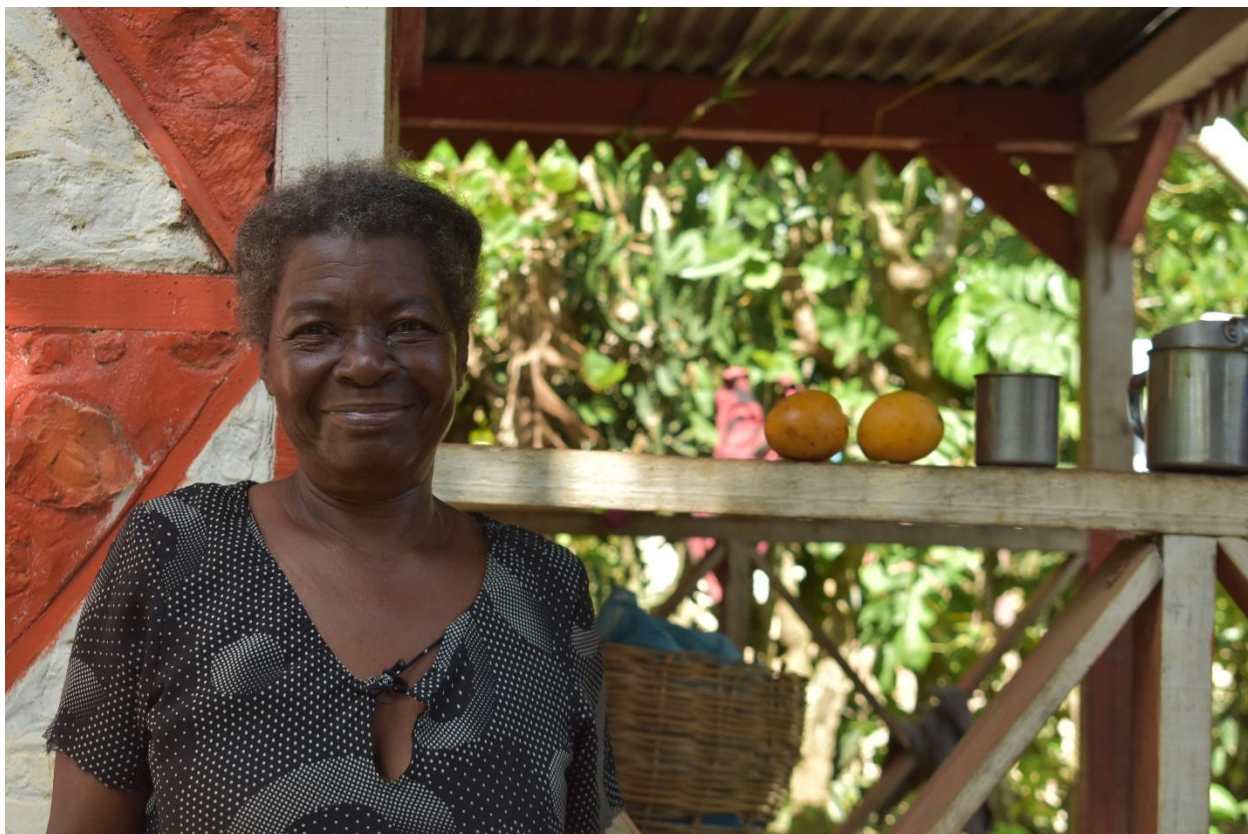
Oxelia (pictured above) is the owner of a TECLA designed house in Corail. Following the earthquake, she told Habitat for Humanity Haiti, "We were all too afraid to go back into the house because you could still feel aftershocks. But now it has been days, and I see that my neighbors' houses have a lot of cracks, but mine is fine."

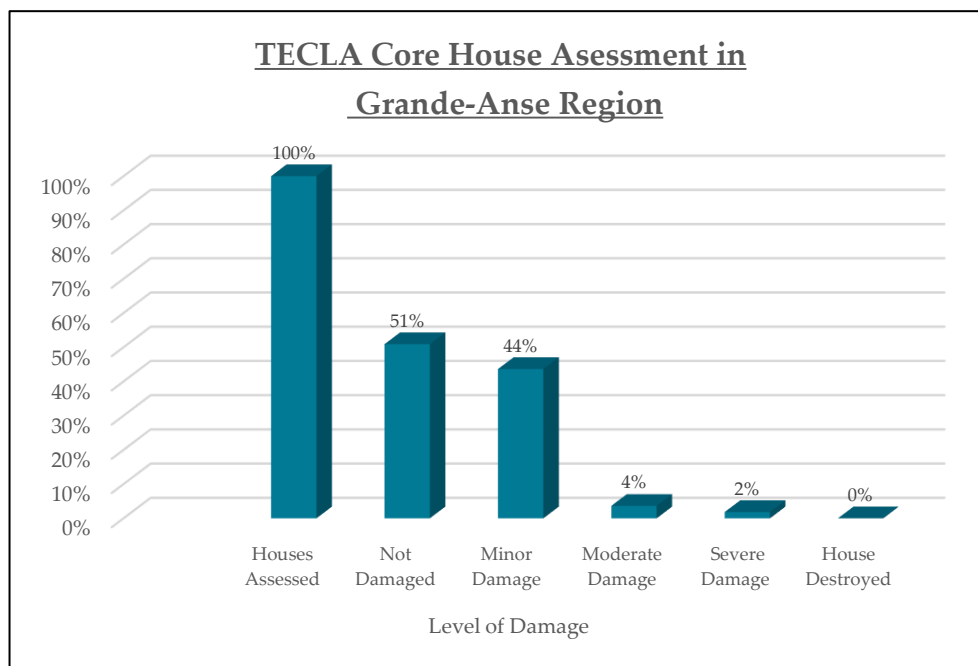
- **51%** of the houses did not sustain any damage. The overall structure stood firm, and all the key components, such as the foundation, joints, beams, trusses, walls, roof, floor, and columns/posts were intact. No cracks were identified.

- **44%** of the houses assessed had minor damage, with the stone masonry collapsing in one (1) to three (3) triangles from the braced panel or showing minor cracks or having the stone masonry unsealed on the bracing. However, the architecture of TECLA houses was designed to react to earthquakes in this way. In the event of an earthquake, the masonry filling the triangles formed by the braces could fall, and then be easily repaired by a local technician or a member of the household.

- **4%** of these houses have moderate damages, with one (1) to three (3) braced panels broken, and the stone masonry collapsed in some of the braced triangles. Such repairs will require skilled masons. However, most of the filling materials are recyclable, and even some of the wood can be reused.

- **2%** of these houses have severe damages. This means that the homes had moderate damages plus one or several mains post as well as intermediary post broken, causing a whole wall to bend or collapse.

- **0%** of the homes were destroyed.

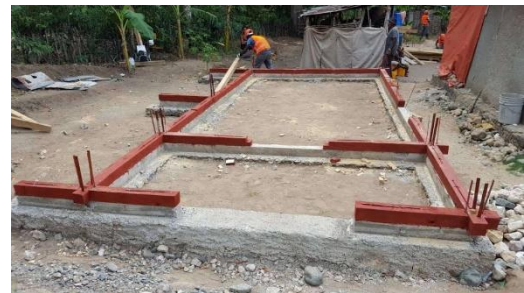
- Loss of resilience of wood due to rotting caused by moisture well before the earthquake
- Insufficient anchoring (number of nails) of stone masonry on the lintel elements of doors and windows
- Insufficient anchoring (number of nails) of the stone masonry on the laths constituting the cross bracing (St. Andrew's Cross)

- Better preparation or treatment of the wood in general, but especially of the bottom rail and posts: use of zinc chromate and paint or other treatment method
- Covering the bottom rail with plastic on the upper and outer sides, plus iron mesh to facilitate plastering.
- Increasing the height of the low wall and spreading a drainage layer on the slope to facilitate rainwater runoff on the ground outside the foot of the foundation
- Increasing the anchorage by adding additional nails in the crossbars
- Adding welded mesh or a 5cm x 5cm grid binding net on the inside of the panels to limit human damage

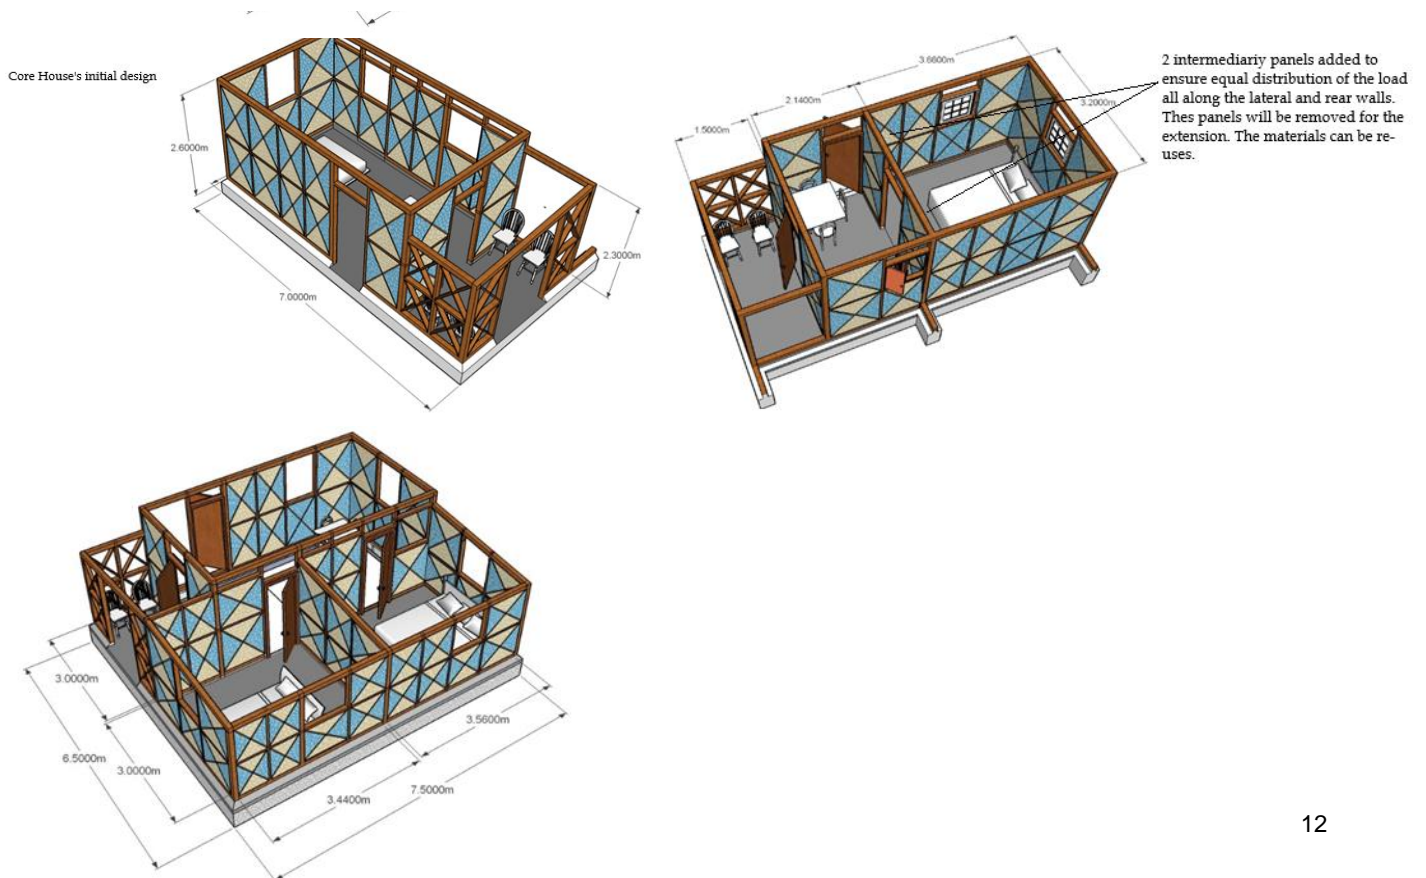
Almost all affected houses presented some weakness in the rear wall.

- Addition of two (2) new interior panels in the width direction, for a better redistribution of the forces

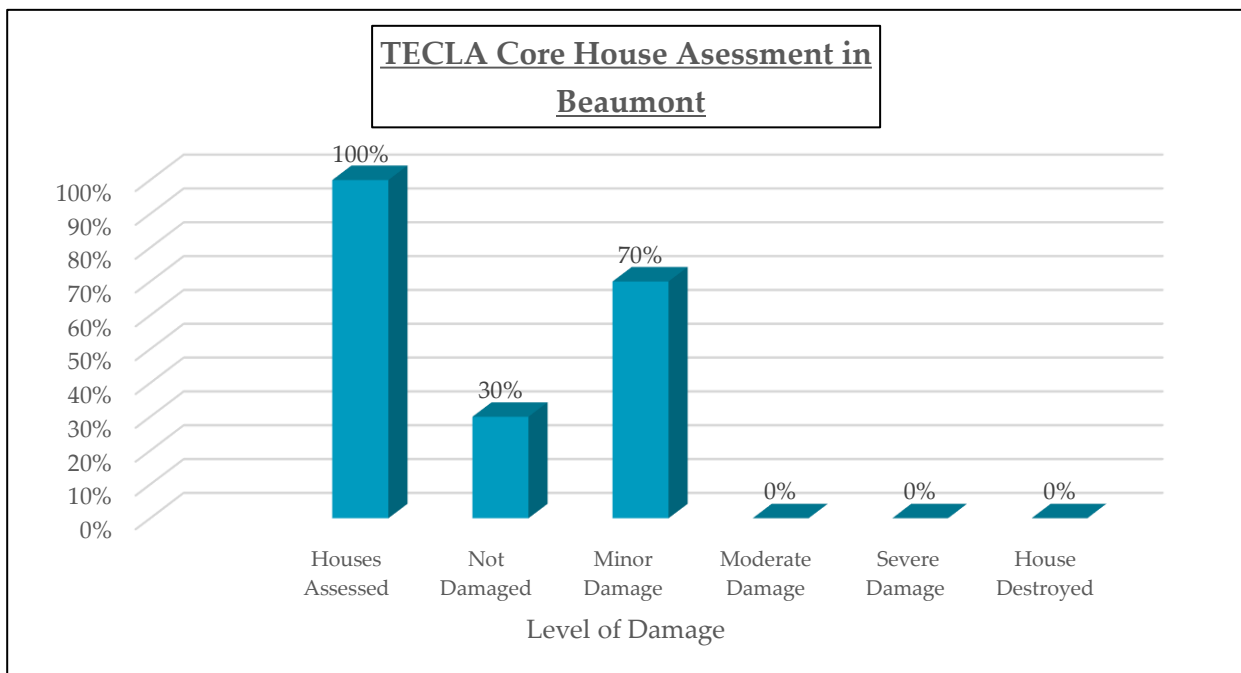
BEAUMONT

1. **100%** of the houses built by HFHH were able to withstand the August 14 earthquake. No death or injuries were reported from people living in the houses.
2. **30%** of the houses had no damage. The overall structures stood firm, with no damage to the roof or the floor.
3. **70%** of the houses assessed had minor damage that could be rapidly repaired by the local masons previously trained by HFHH.
4. None of them (**0%**) were moderately or severely damaged or destroyed.

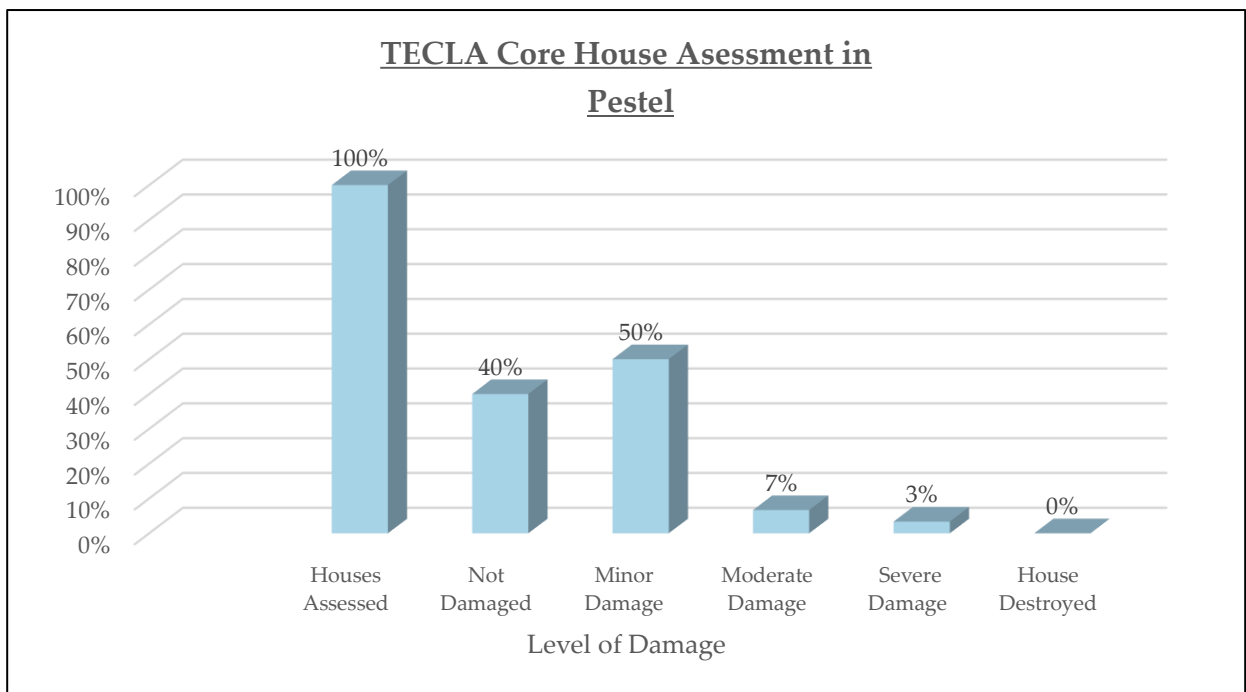
PESTEL

1. **100%** of the houses built by HFHH were able to withstand the August 14 earthquake. No death or injuries were reported from people living in the houses
2. **40%** of the houses had no damage. The overall housing structures did not suffer any type of damages.
3. **50%** of the houses assessed had minor damage that could be rapidly repaired by the local masons previously trained by HFHH.
4. **7%** of the homes had moderate damages which will require repairs by local, skilled masons who had been previously trained on TECLA techniques.
5. **3%** of the homes were severely damaged, suffering moderate damages and one or more main posts, as well as intermediary post broken, causing the whole wall bend or collapse.
5. None (**0%**) were destroyed

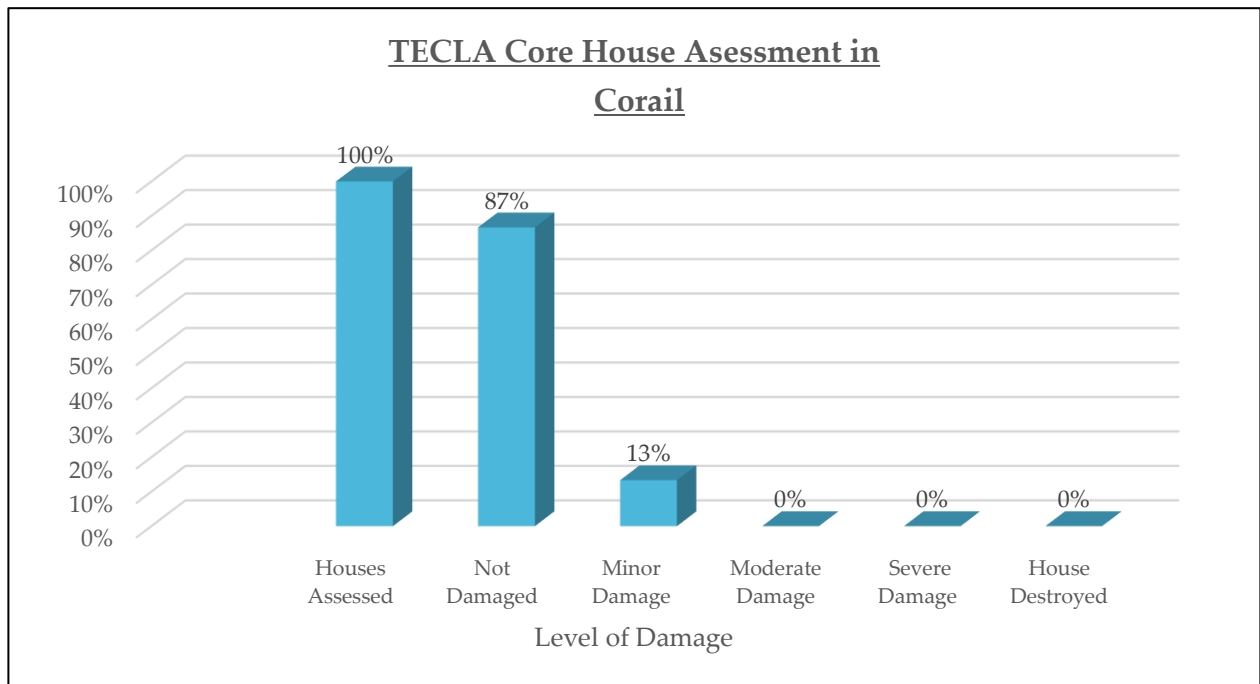
CORAIL

1. **100%** of the houses built by HFHH were able to withstand the August 14 earthquake. No death or injuries were reported from people living in the houses,
2. **87%** of the houses had no damage. The overall housing structures did not suffer any type of damages.
3. **13%** of the houses had minor damage that could be rapidly repaired by the local masons previously trained by HFHH.
4. None of them (**0%**) were moderately or severely damaged or destroyed.
